Navajo Abandoned Uranium Mine

Site Screen Report

Enos Johnson 1, Enos Johnson 2 AUM Site

March 2010

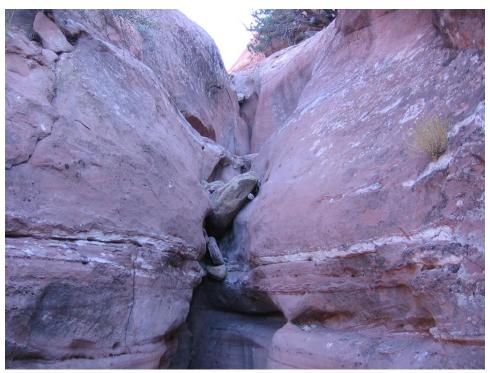
Photo 1. Path towards site

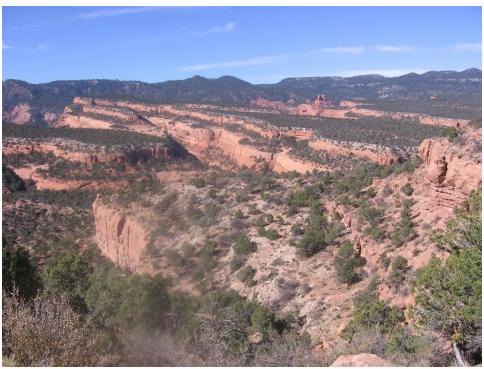
Photo 2. Direction of site

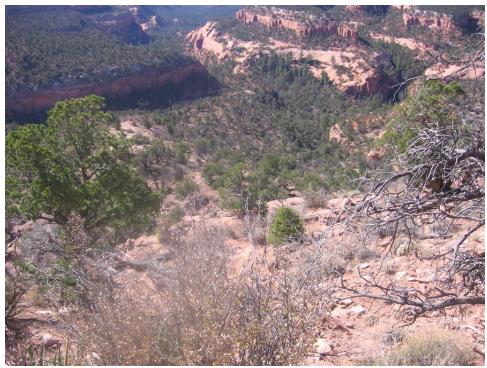
Photo 3. Site below

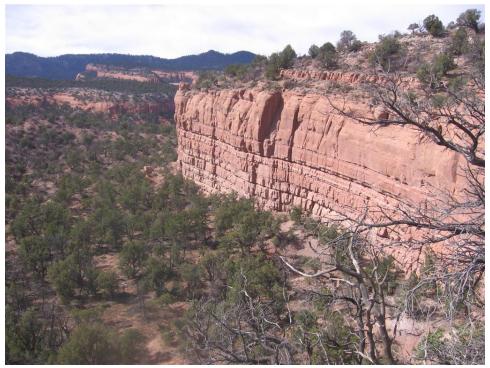
Photo 4. Site below

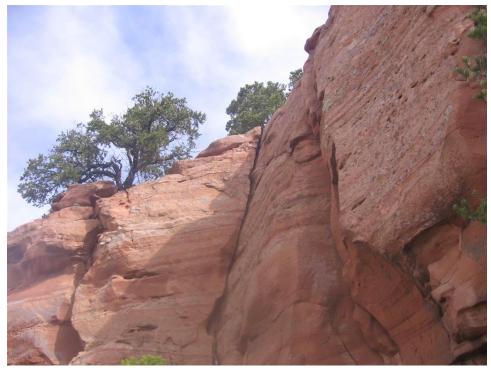
Photo 5. Cliff area

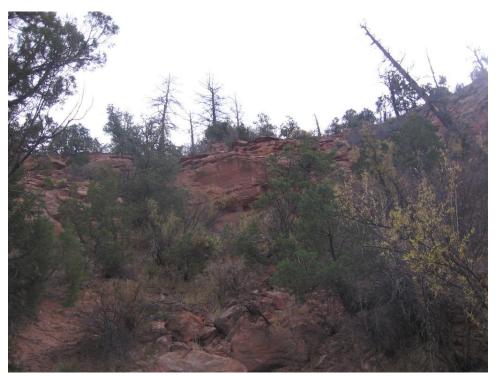
Photo 6. Cliff area

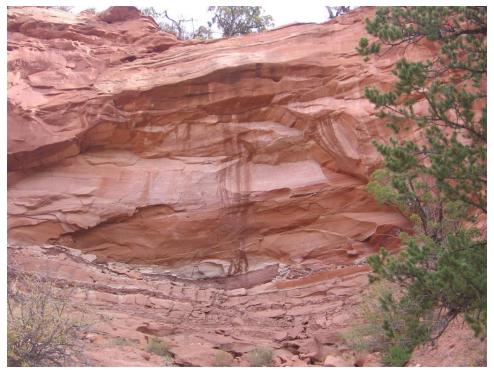
Photo 7. Drainage above site

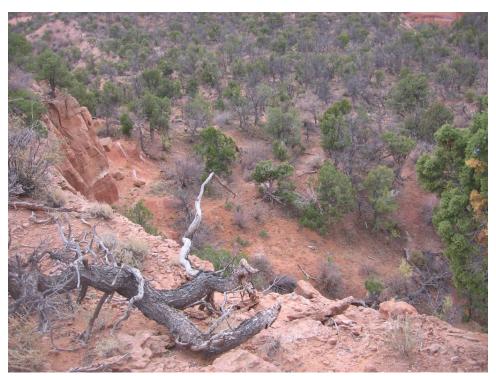
Photo 8. Site below

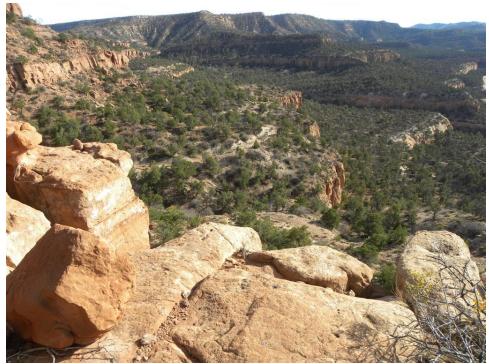
Photo 9. Site below

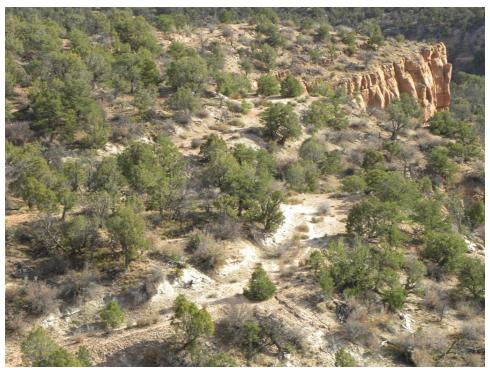
Photo 10. Site below

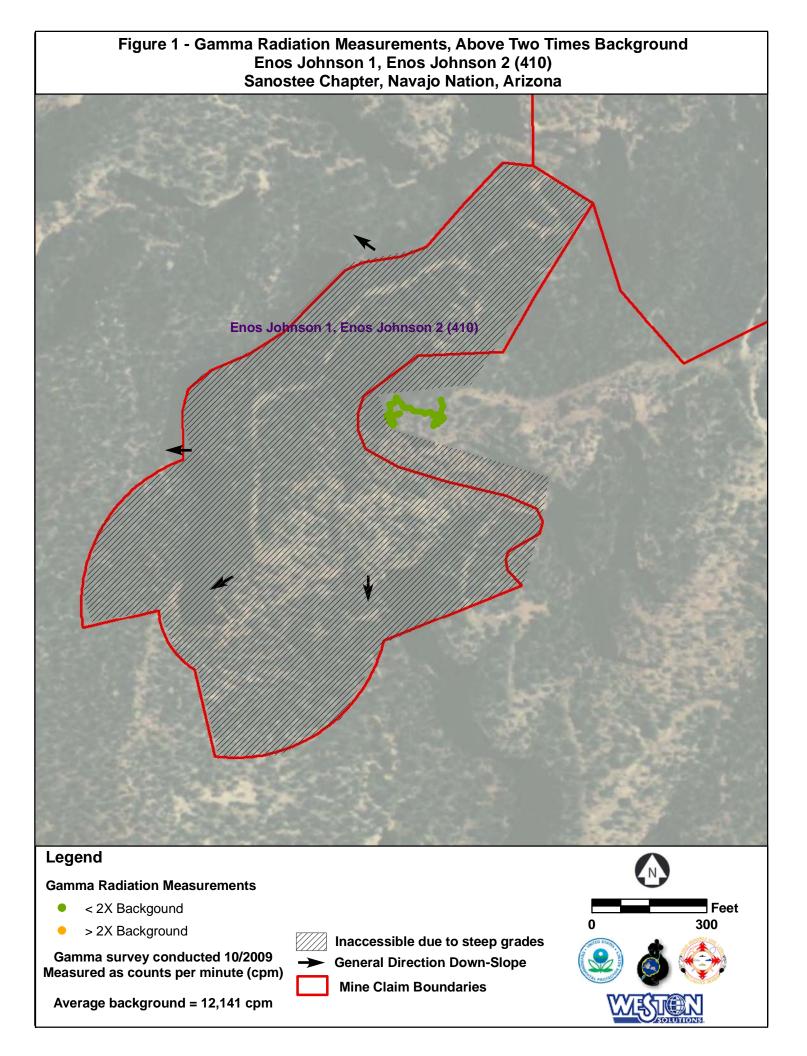
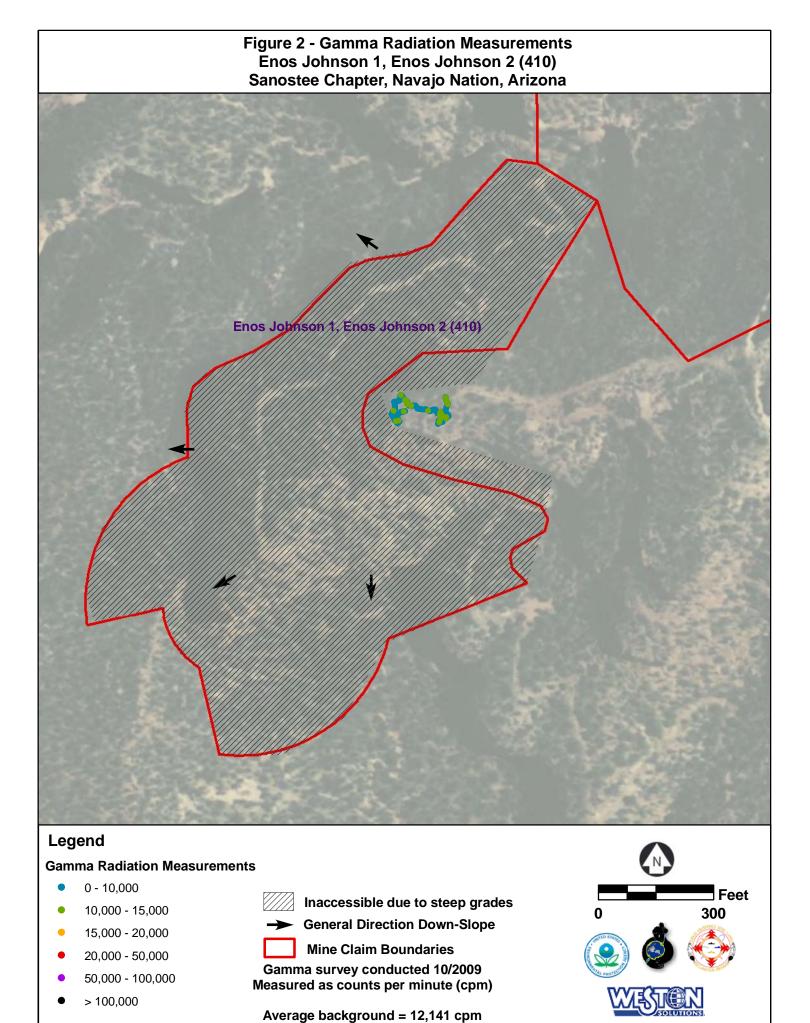
Weston was unable to access the site, due to steep grades all known paths to the site were impassible. Measurements were collected in the vicinity of the site, from a plateau approximately 50' east of the site boundary. A total of 295 gamma radiation measurements were collected near the mine site, ranging from 6,134 cpm to 11,526 cpm. The measurements are represented in Figures 1 and 2.
